# DRAG<sup>®</sup> valves give Kuosheng a 24 MWe boost

Leaking feedwater recirculation valves at Taiwan Power's second nuclear station, Kuosheng, had for many years cut into the plant's efficiency and reduced output. By replacing them with DRAG<sup>®</sup> valves from Control Components Inc (CCI), the station generating capacity was boosted by 24 MWe with the bonus of a significant reduction in maintenance costs.

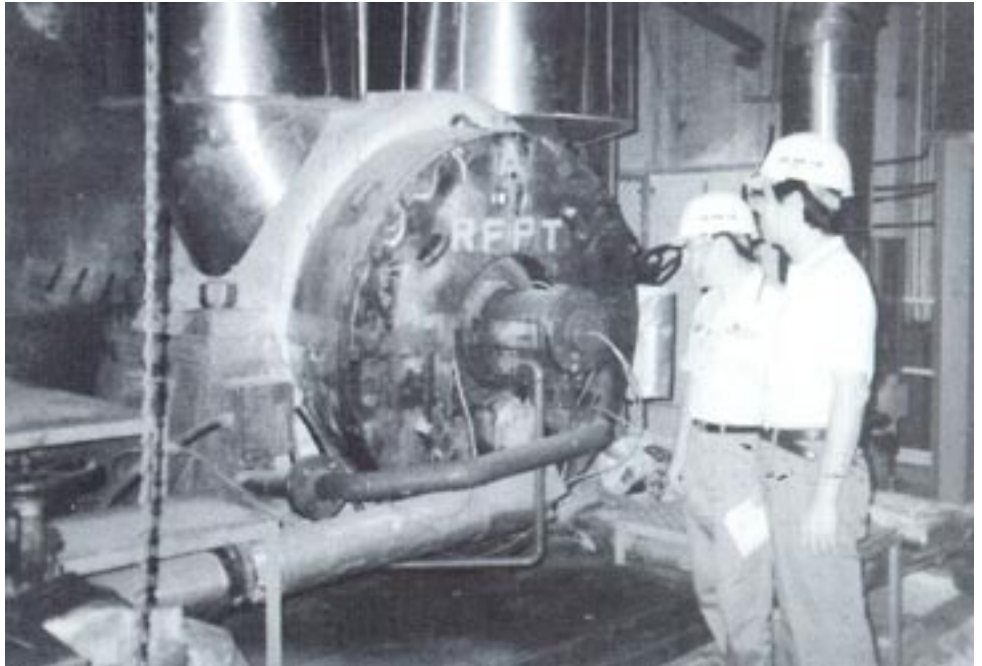
The Kuosheng 2 reactor feedwater pump.

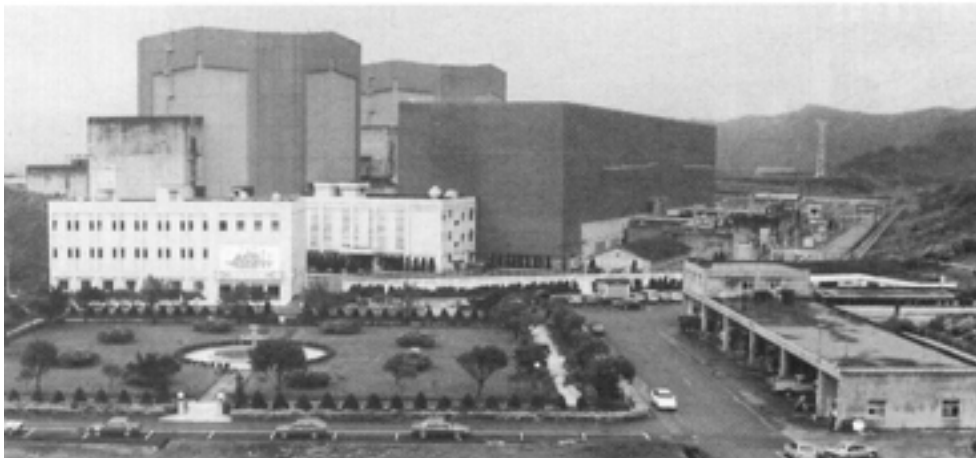
*The Kuosheng station (2 X 985 MWe BWRs) is the second of Taiwan Power's three operating nuclear plants. Located on the northern coast of Taiwan, the plant began operating in 1981.*
